MODEL 6P1 PORTABLE RADIO RECEIVER

IMPORTANT SERVICE INSTRUCTION

INSTRUCTIONS FOR REPLACING RECTIFIER ASSEMBLY

MODEL 6PI / SCHEMATIC

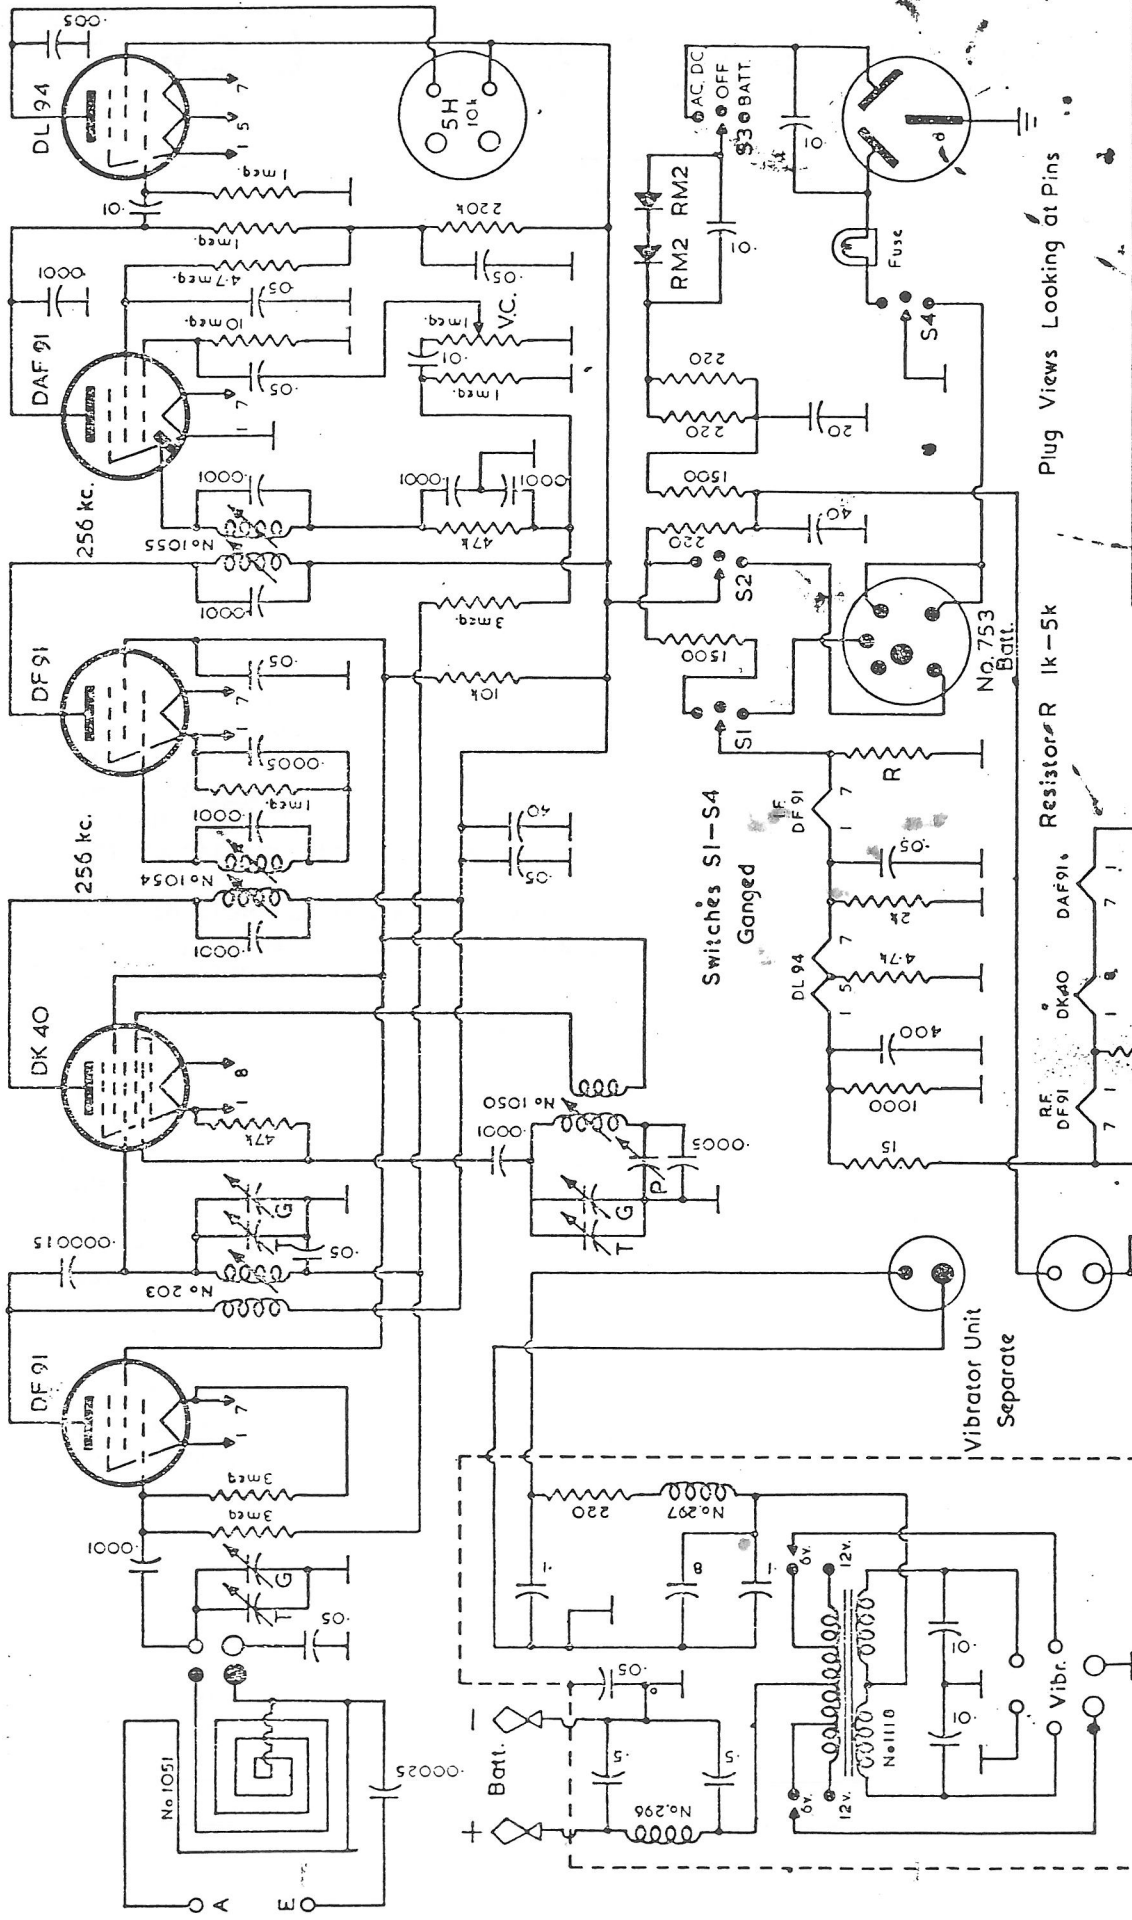
DRG. NO. 1124
AKRAD RADIO CORP. LTD.
WAIHI

Plug Views Looking at Pins

Resistor R 1k-5k

Vibrator Unit Separate

On opening the back of the receiver, removing the battery and the cardboard cover surrounding the chassis (which is there for the purpose of preventing the chassis from being touched when operating on AC/DC) the two Dry Rectifiers will be noted on the top lefthand portion of the chassis, as will two 220 Ohm Resistors in parallel, between the rectifiers and the 1500 Ohm Wire Wound Resistor. It is recommended that these two 220 Ohm Resistors in parallel be lifted from their point of attachment to the 1500 Ohm Wire Wound resistor and that two more 220 Ohm 1 watt resistors in parallel be inserted to make a total resistance of 220 Ohms between the rectifiers and the Wire Wound resistor. In other words there will be four resistors in series parallel.

This modification will reduce the AC voltage across the rectifiers and also slightly reduce the H.T. voltage applied to the plates of the valves in the receiver but there will be no deterioration in performance by virtue of this modification.

IMPORTANT: Please note that the positive end of the rectifier stack must go to the side nearest to the wire wound resistor to which it must be connected through the series parallel carbon resistors, the total resistance of which will be 220 ohms.
